FALL IMPACT EVALUATION OF 62.8" x 94.9" DOME SKYLIGHT "6496 FPS-FF" For: ARTISTIC SKYLIGHT DOMES LTD.

Report to:	Artistic Skylight Domes Ltd. 255 Regina Rd. Woodbridge, ON L4L 8M3
Attention: E-mail: Telephone:	Mr. Nenzio Ferrazzo nenzio.ferrazzo@artisticskylight.com 416-747-7233
Report No.:	16-06-M0200-2 RV1 3 Pages, 2 Appendix
Proposal No.:	16-006-406643
Date:	August 31, 2016

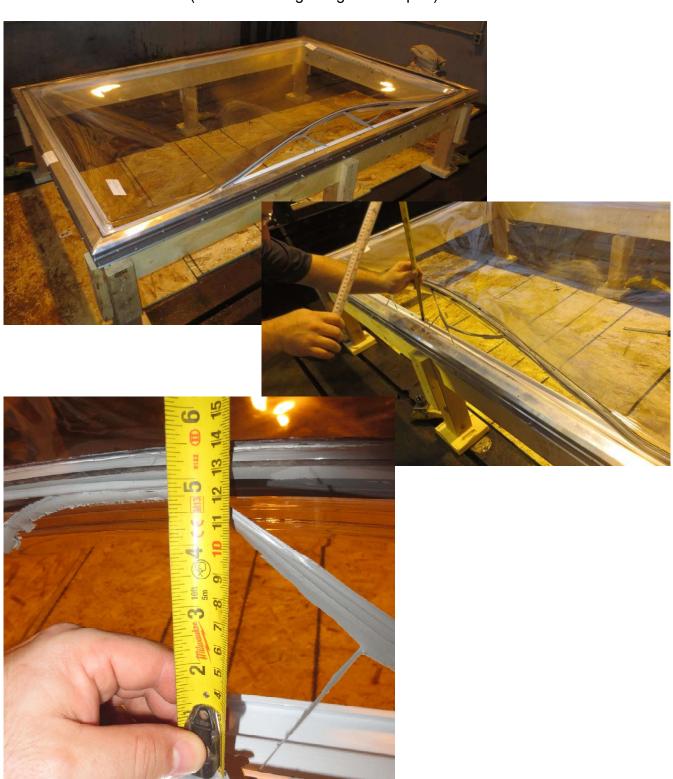
Height (ft)	Load (lbs)	Energy (ft/lbs)	Observation	Photograph (Appendix A)
3	250	750	No Damage	1
3.875	250	968.75	No Damage	
4	250	1000	 Permanent deglazing at the mid-span between the sealed unit and aluminum retaining frame. Permanent deglazing at the corner between the sealed unit and aluminum retaining frame. Weight did not pass through the opening 	2-3
5	250	1250	N/A	
6	250	1500	N/A	
7	250	1750	N/A

Picture 2 (Permanent deglazing at mid-span)

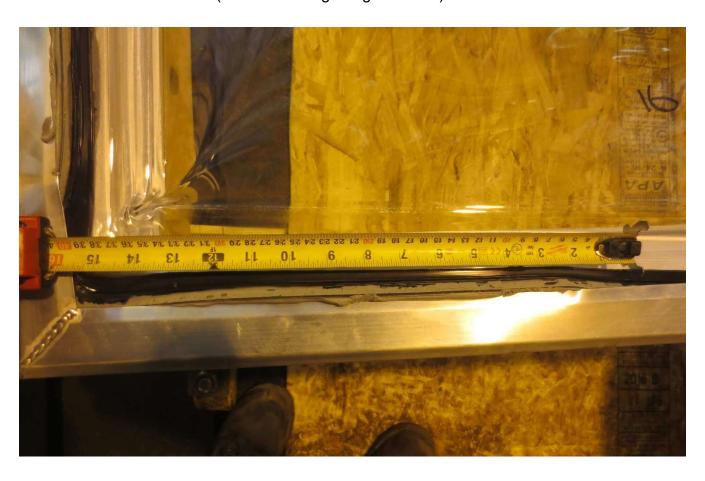
Picture 3 (Permanent deglazing at corner)
