ARTISTIC SKYLIGHT DOMES

Test Report	No: T1248-4R2	Revision Date: November 9, 2021				
SAMPLE ID:	Artistic Skylight Domes – Fa	all Protection Screen.				
SAMPLING DETAIL:	Client had submitted the samples directly to QAI for testing.					
DATE OF RECEIPT:	Three (3) skylight domes and fall protection screen assemblies were received at QAI on August 4, 2021.					
TESTING PERIOD:	September 10, 2021.					
AUTHORIZATION:	QAI Proposal Number 21M quote and PO 21-205-nf on	A042101 dated April 21, 2021 was accepted by signed May 14, 2021.				
TEST(S) REQUESTED:	Static load testing to CAL CAL-OSHA Section 3212 (-OSHA Section 3212 (b) and Impact load testing to e1) requirements.

STATIC LOAD - CAL-OSHA Section 3212 (b)

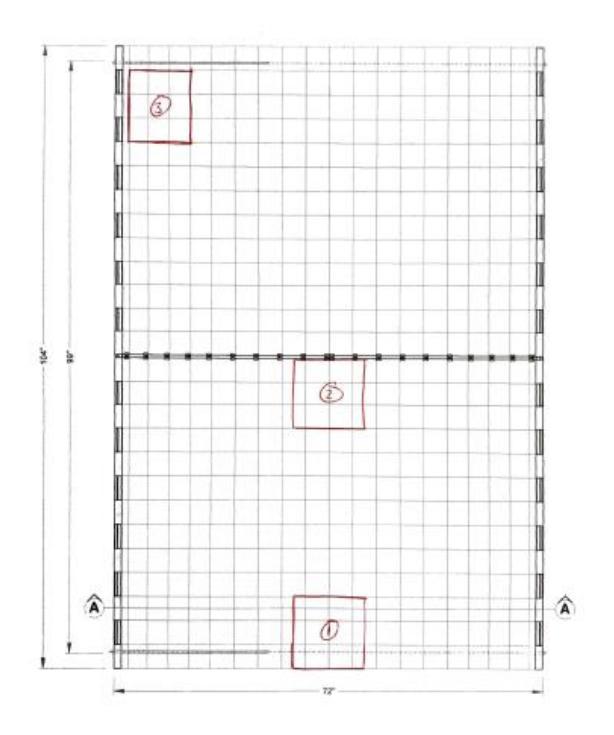
After review of the screen profile and the relationship to the skylight dome, three (3) locations were picked to be used as test sites, and are shown in the diagram below:

- Location 1 Center of front edge of fall protection screen.
- Location 2 Center of screen connection seam, offset to side (only 1 screen loaded).
- Location 3 Edge of fall protection screen.

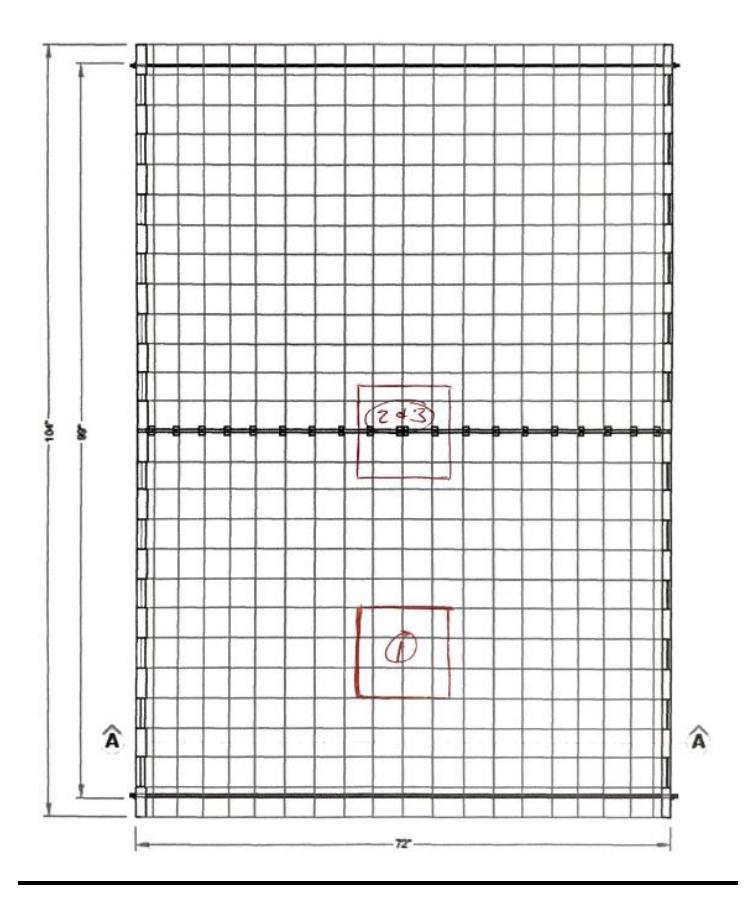
After review of the screen profile and the relationship to the skylight dome, three (3) locations were picked to be used as test sites, and are shown in the diagram below. For each test, a new screen assembly was used.

Location 1 – Center of one section of fall protection screen. Locations 2 & 3 – Center of screen connection seam, both screens loaded.

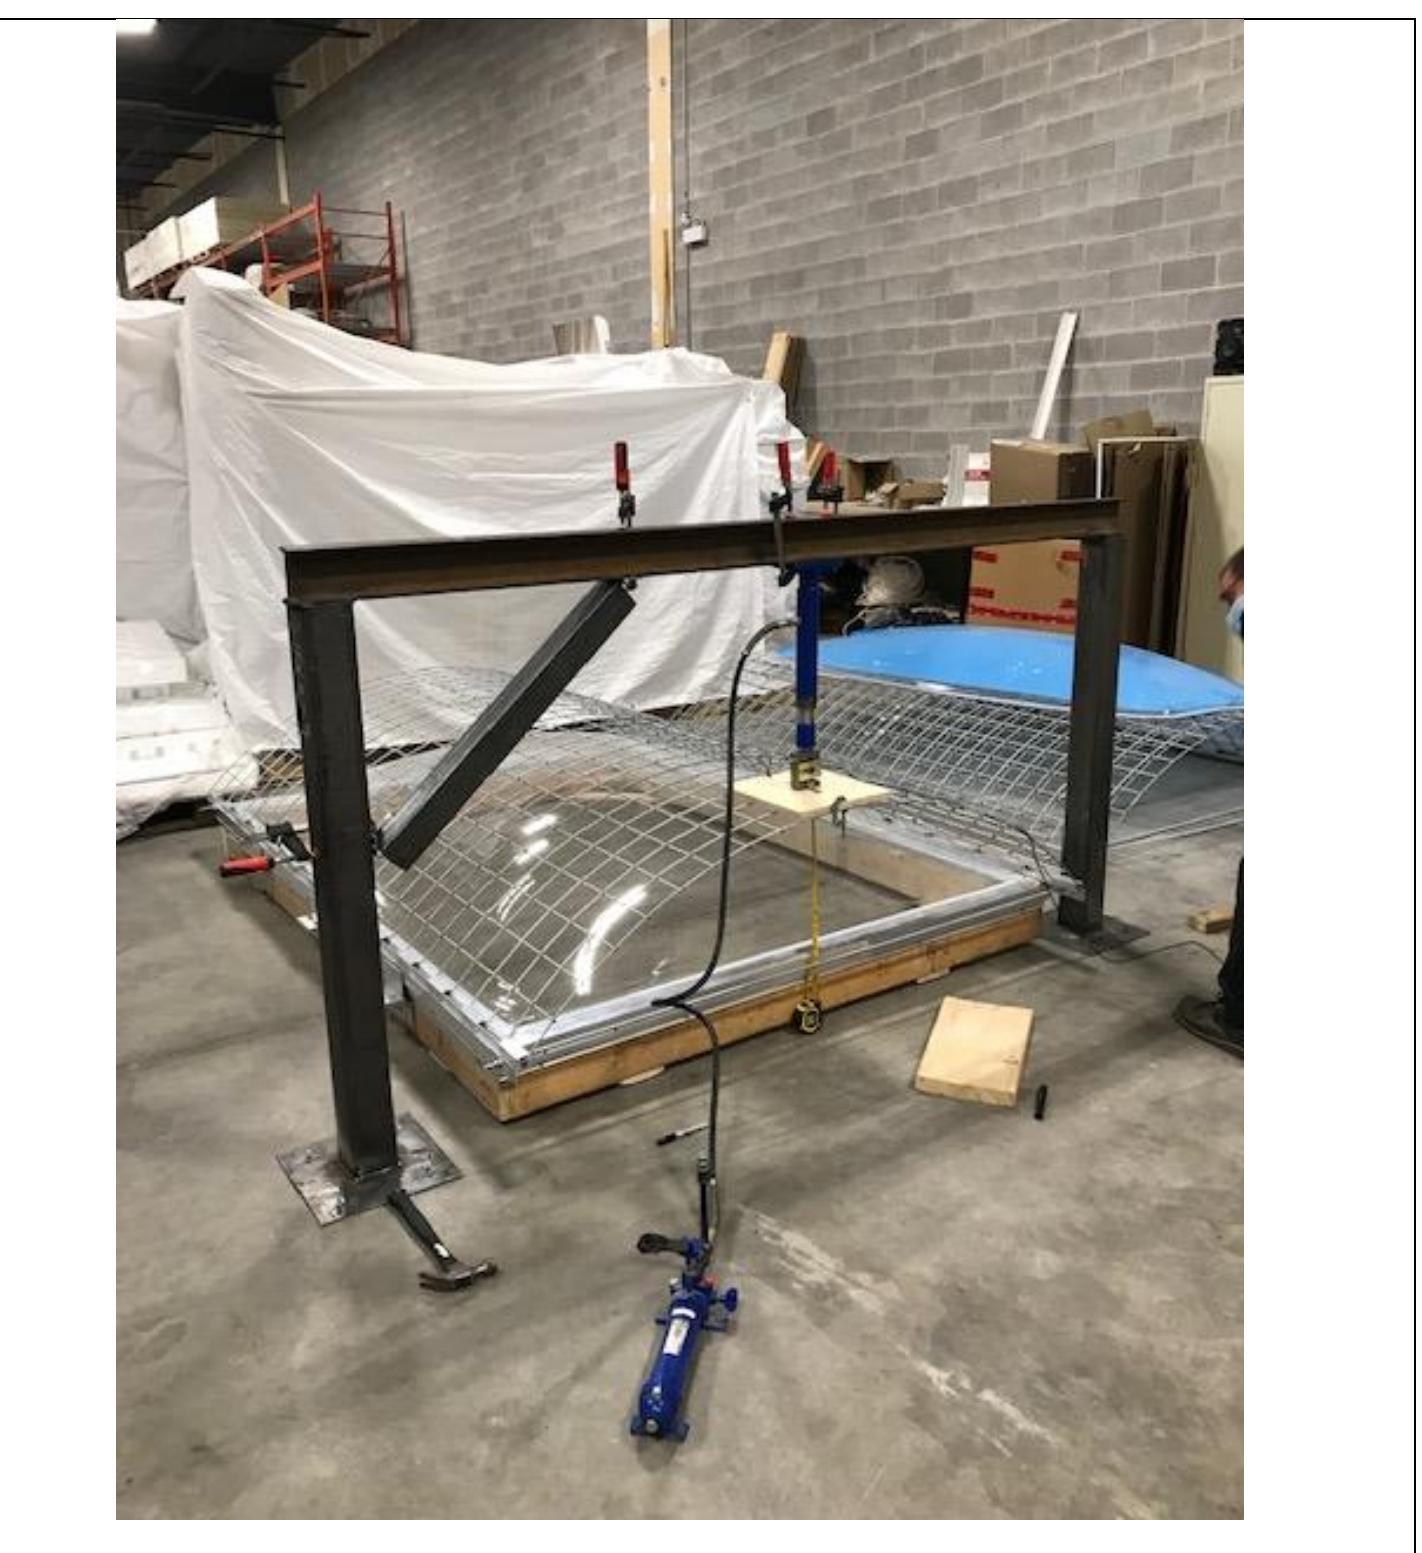
Photo 1. Static Load Location #1

Load VS. Deflection Data										
Location	Load	Initial Displacement		Under Load		Deflection		After Release Displacement		t Commonto	
Location	lbs	mm	in	mm	in	mm	in	in mm in Comments		comments	
	0	446.0875	17 9/16					446.0875	17 9/16	No signs of deformation.	
1	175	446.0875	17 9/16	331.7875	13 1/16	114.30	4 1/2	441.325	17 3/8	Signs of deformation (bending) of screen.	
1	200	441.325	17 3/8	276.225	10 7/8	165.10	6 1/2	436.5625	17 3/16	Signs of deformation (bending) of screen.	
	215	436.5625	17 3/16	112.7125	4 7/16	323.85	12 3/4	400.05	15 3/4	Yield of screen achieved. Cannot sustain further loading.

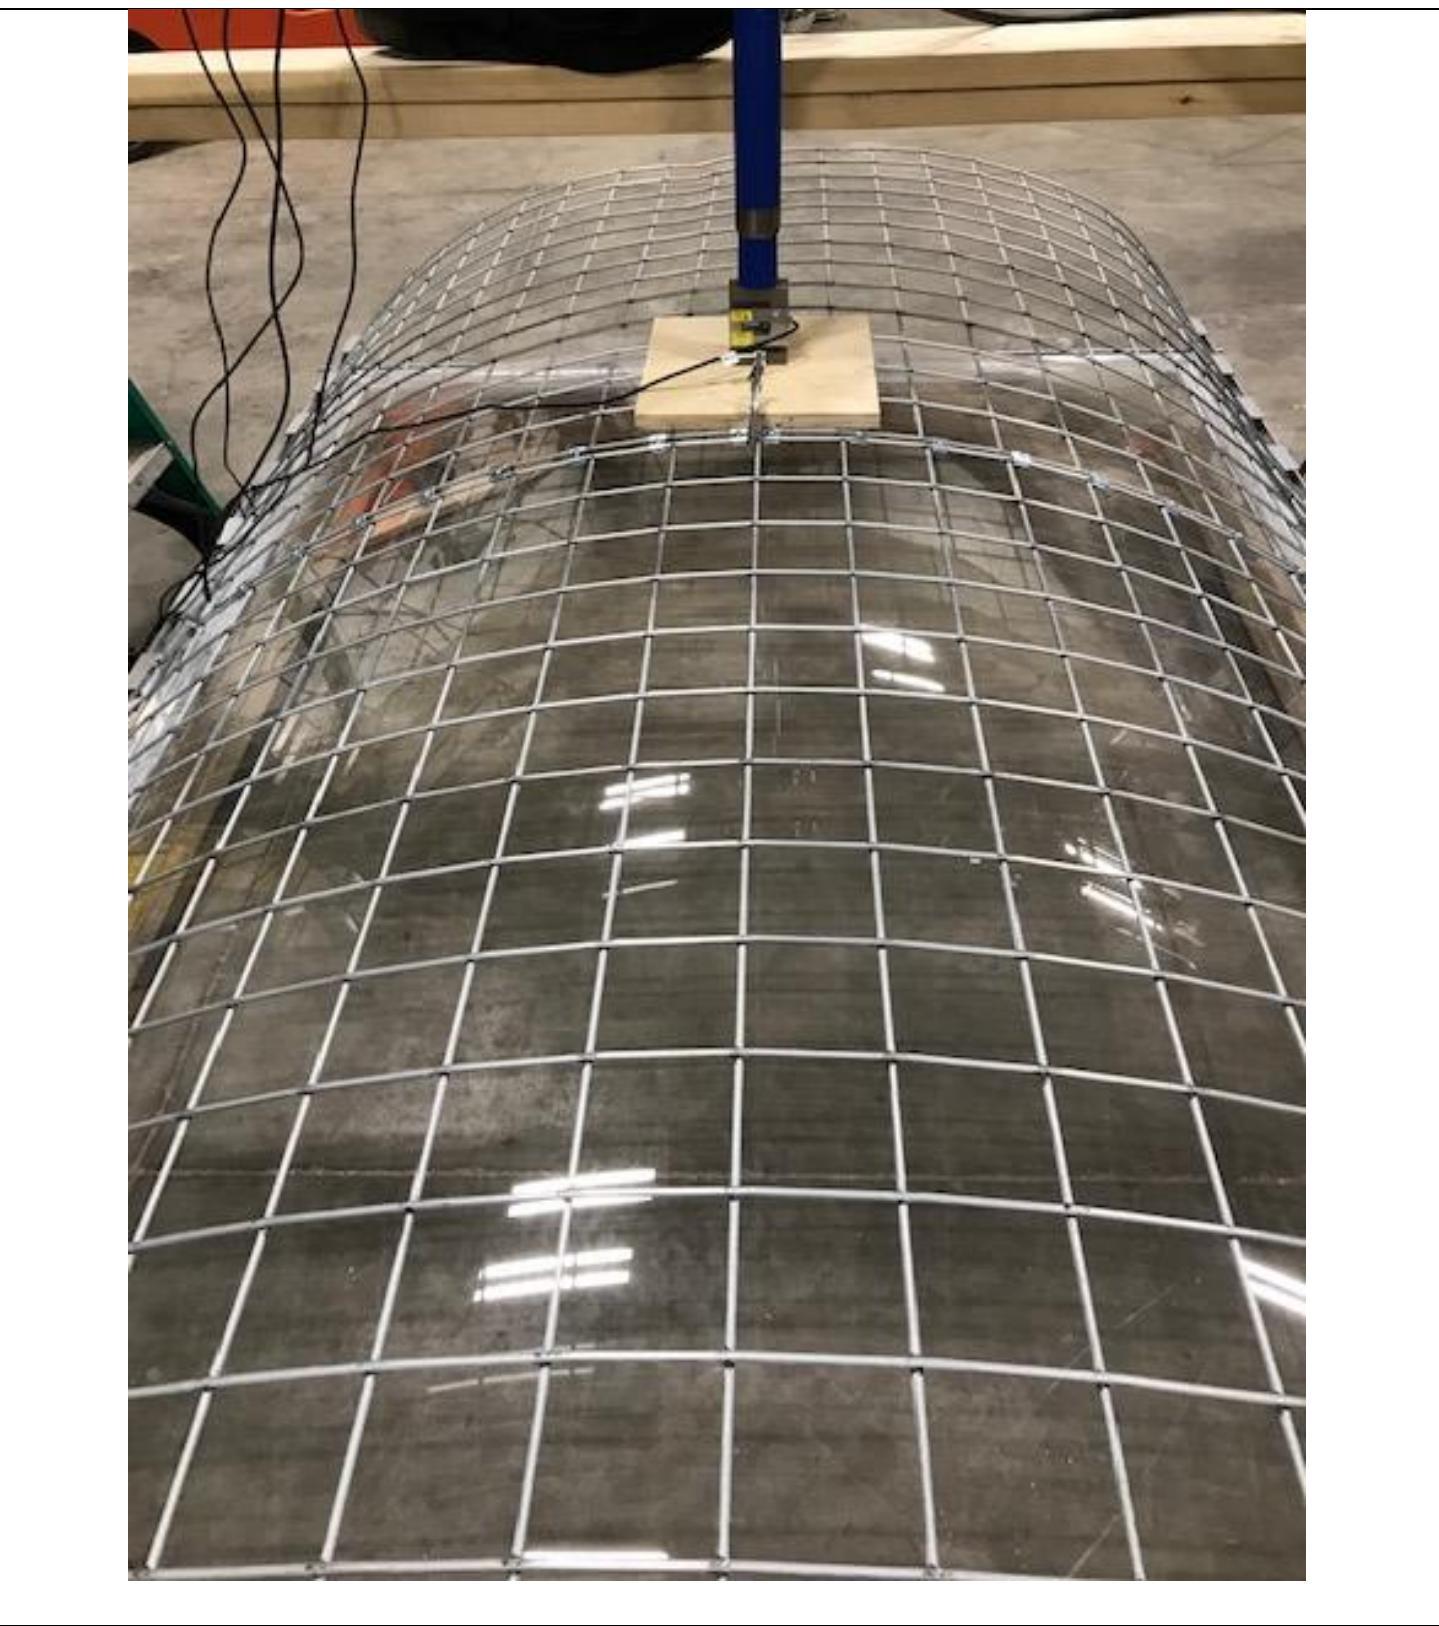
Photo 2. Static Load Location #2

Load VS. Deflection Data											
Location	Load	Initial Dis	placement	Unde	Under Load		ction	After Release Displacement		6t-	
Location	lbs	mm	in	mm	in	mm	in	mm	in	comments	
	0	701.675	27 5/8					701.675	27 5/8	No signs of deformation.	
	200	701.675	27 5/8	762	30	60.325	2 3/8	701.675	27 5/8	No signs of deformation.	
	309	701.675	27 5/8	804.8625	31 11/16	103.1875	4 1/16	701.675	27 5/8	Screen in contact with dome.	
	400	701.675	27 5/8	838.2	33	136.525	5 3/8	708.025 27 7/8 Signs of deformation	Signs of deformation (bending) of screen.		
	425	708.025	27 7/8	849.3125	33 7/16	141.2875	5 9/16	709.6125	27 15/16	Signs of deformation (bending) of screen.	
2	440	709.6125	27 15/16	857.25	33 3/4	147.6375	5 13/16	708.025	27 7/8	Screen touching dome.	
	450	708.025	27 7/8	858.8375	33 13/16	150.8125	5 15/16	712.7875	28 1/16	Screen touching dome.	
	500	712.7875	28 1/16	871.5375	34 5/16	158.75	6 1/4	712.7875	28 1/16	Outer shell of dome deforming - no breakage.

600	712.7875	28 1/16	900.1125	35 7/16	187.325	7 3/8	717.55	28 1/4	Outer shell of dome deforming - no breakage.	
	700	717.55	28 1/4	942.975	37 1/8	225.425	8 7/8	730.25	28 3/4	Outer shell of dome deforming - no breakage.	
	725	730.25	28 3/4	1008.0625	39 11/16	277.8125	10 15/16	730.25	28 3/4	Outer shell of dome deforming - no breakage.

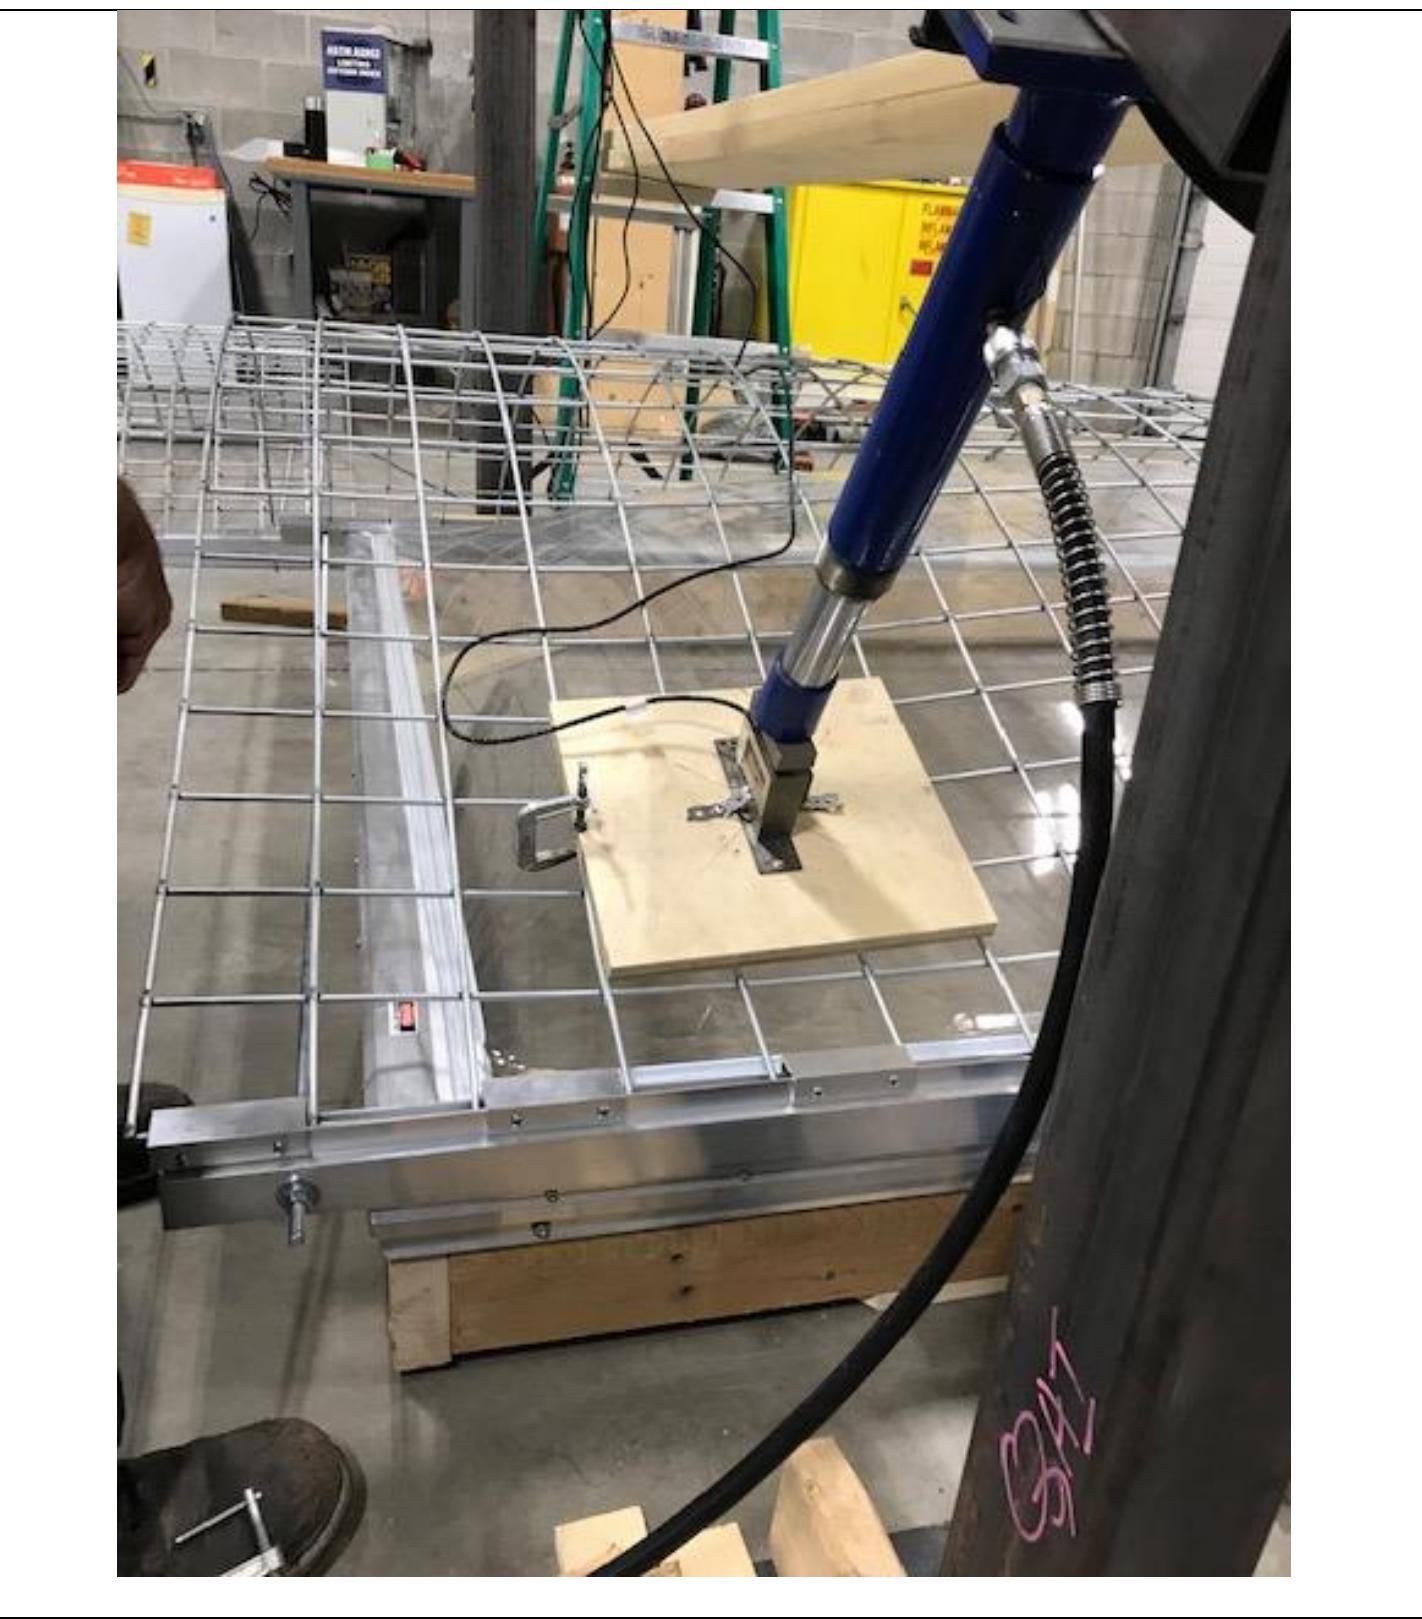
Photo #4. Static Load Location #3 – Under Load

Load VS. Deflection Data										
Location	Load	Initial Displacement		Under Load		Defle	Deflection		Displacement	Commonts
Location	lbs	mm	in	mm	in	mm	mm in mm in commen		comments	
	0	806.45	31 3/4					806.45	31 3/4	No signs of deformation.
	200	806.45	31 3/4	836.6125	32 15/16	30.1625	1 3/16	793.75	31 1/4	No signs of deformation.
	300	793.75	31 1/4	852.4875	33 9/16	58.7375	2 5/16	792.1625	31 3/16	No signs of deformation.
	400	792.1625	31 3/16	873.125	34 3/8	80.9625	3 3/16	793.75	31 1/4	No signs of deformation.
2	425	793.75	31 1/4	876.3	34 1/2	82.55	3 1/4	792.1625	31 3/16	No signs of deformation.
5	450	792.1625	31 3/16	884.2375	34 13/16	92.075	3 5/8	793.75	31 1/4	No signs of deformation.
	500	793.75	31 1/4	893.7625	35 3/16	100.0125	3 15/16	794.54375	31 9/32	Screen touching dome.
	600	794.5438	31 9/32	914.4	36	119.85625	4 23/32	801.6875	31 9/16	Screen touching dome.
	700	801.6875	31 9/16	920.75	36 1/4	119.0625	4 11/16	806.45	31 3/4	Screen touching dome.

800	806.45	31 3/4	933.45	36 3/4	127	5	812.8	32	Screen in full contact with dome.

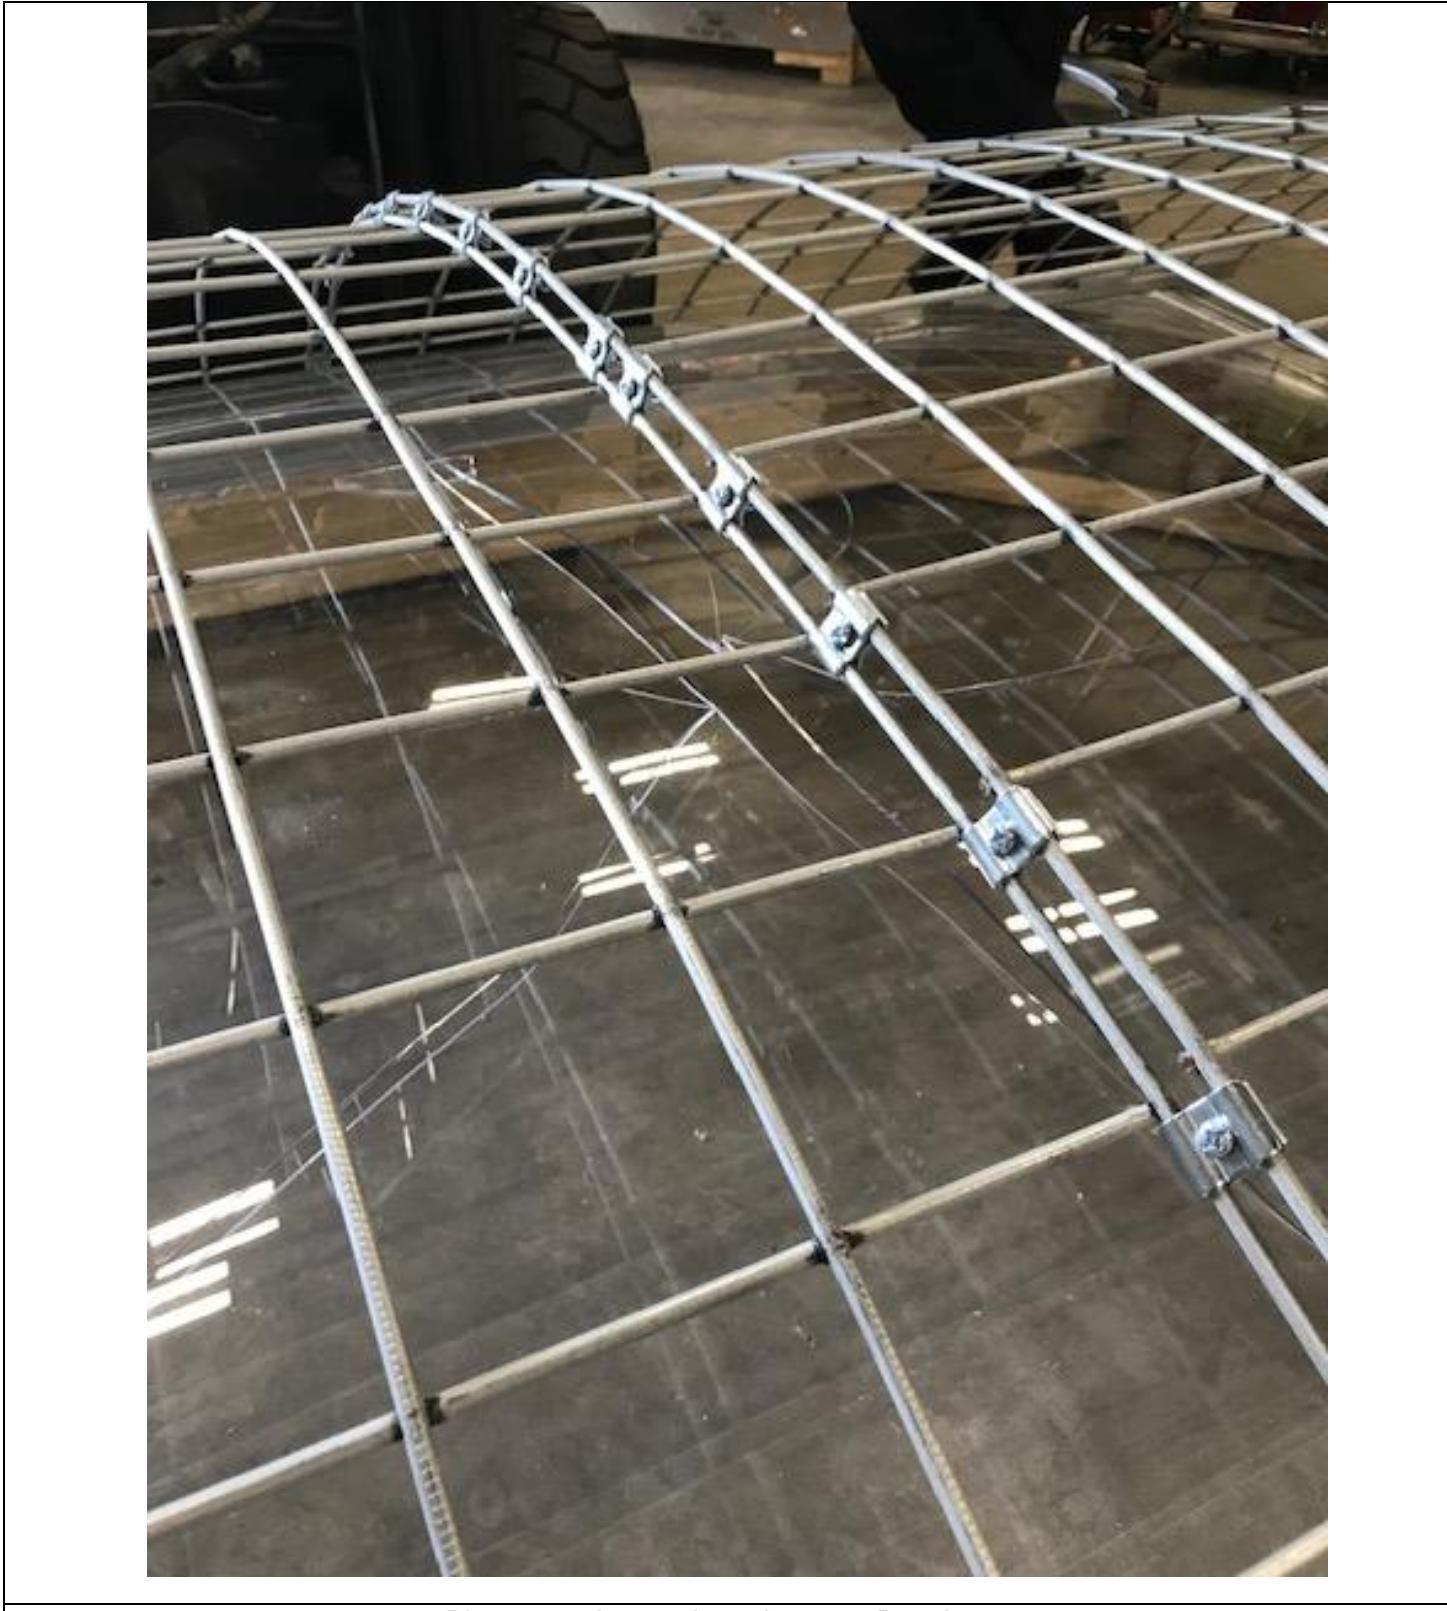
Photo #6 – Impact Location #2 – Post Impact

Test Location	Impact Bag Mass, kg (lbs)	Drop Height, mm (in)	Impact Energy, J (lbf)	Comments
1	45.3 (100)	1295 (51)	576 (425)	Screen deformed/bent. Outer shell of dome broken. Inner shell intact & unbroken. No passage through to interior.
2	45.3 (100)	1295 (51)	576 (425)	Screen deformed/bent. Outer shell of dome broken. Inner shell intact & unbroken. No passage through to interior.
3	45.3 (100)	1295 (51)	576 (425)	Screen deformed/bent. Outer shell of dome broken. Inner shell intact & unbroken. No passage through to interior.
