ARTISTIC SKYLIGHT DOMES

Test Report	No: T1248-4R2	Revision Date: November 9, 2021				
SAMPLE ID:	Artistic Skylight Domes – Fa	all Protection Screen.				
SAMPLING DETAIL:	Client had submitted the samples directly to QAI for testing.					
DATE OF RECEIPT:	Three (3) skylight domes and fall protection screen assemblies were received at QAI on August 4, 2021.					
TESTING PERIOD:	September 10, 2021.					
AUTHORIZATION:	QAI Proposal Number 21M quote and PO 21-205-nf on	A042101 dated April 21, 2021 was accepted by signed May 14, 2021.				
TEST(S) REQUESTED:	Static load testing to CAL CAL-OSHA Section 3212 (-OSHA Section 3212 (b) and Impact load testing to e1) requirements.

STATIC LOAD - CAL-OSHA Section 3212 (b)

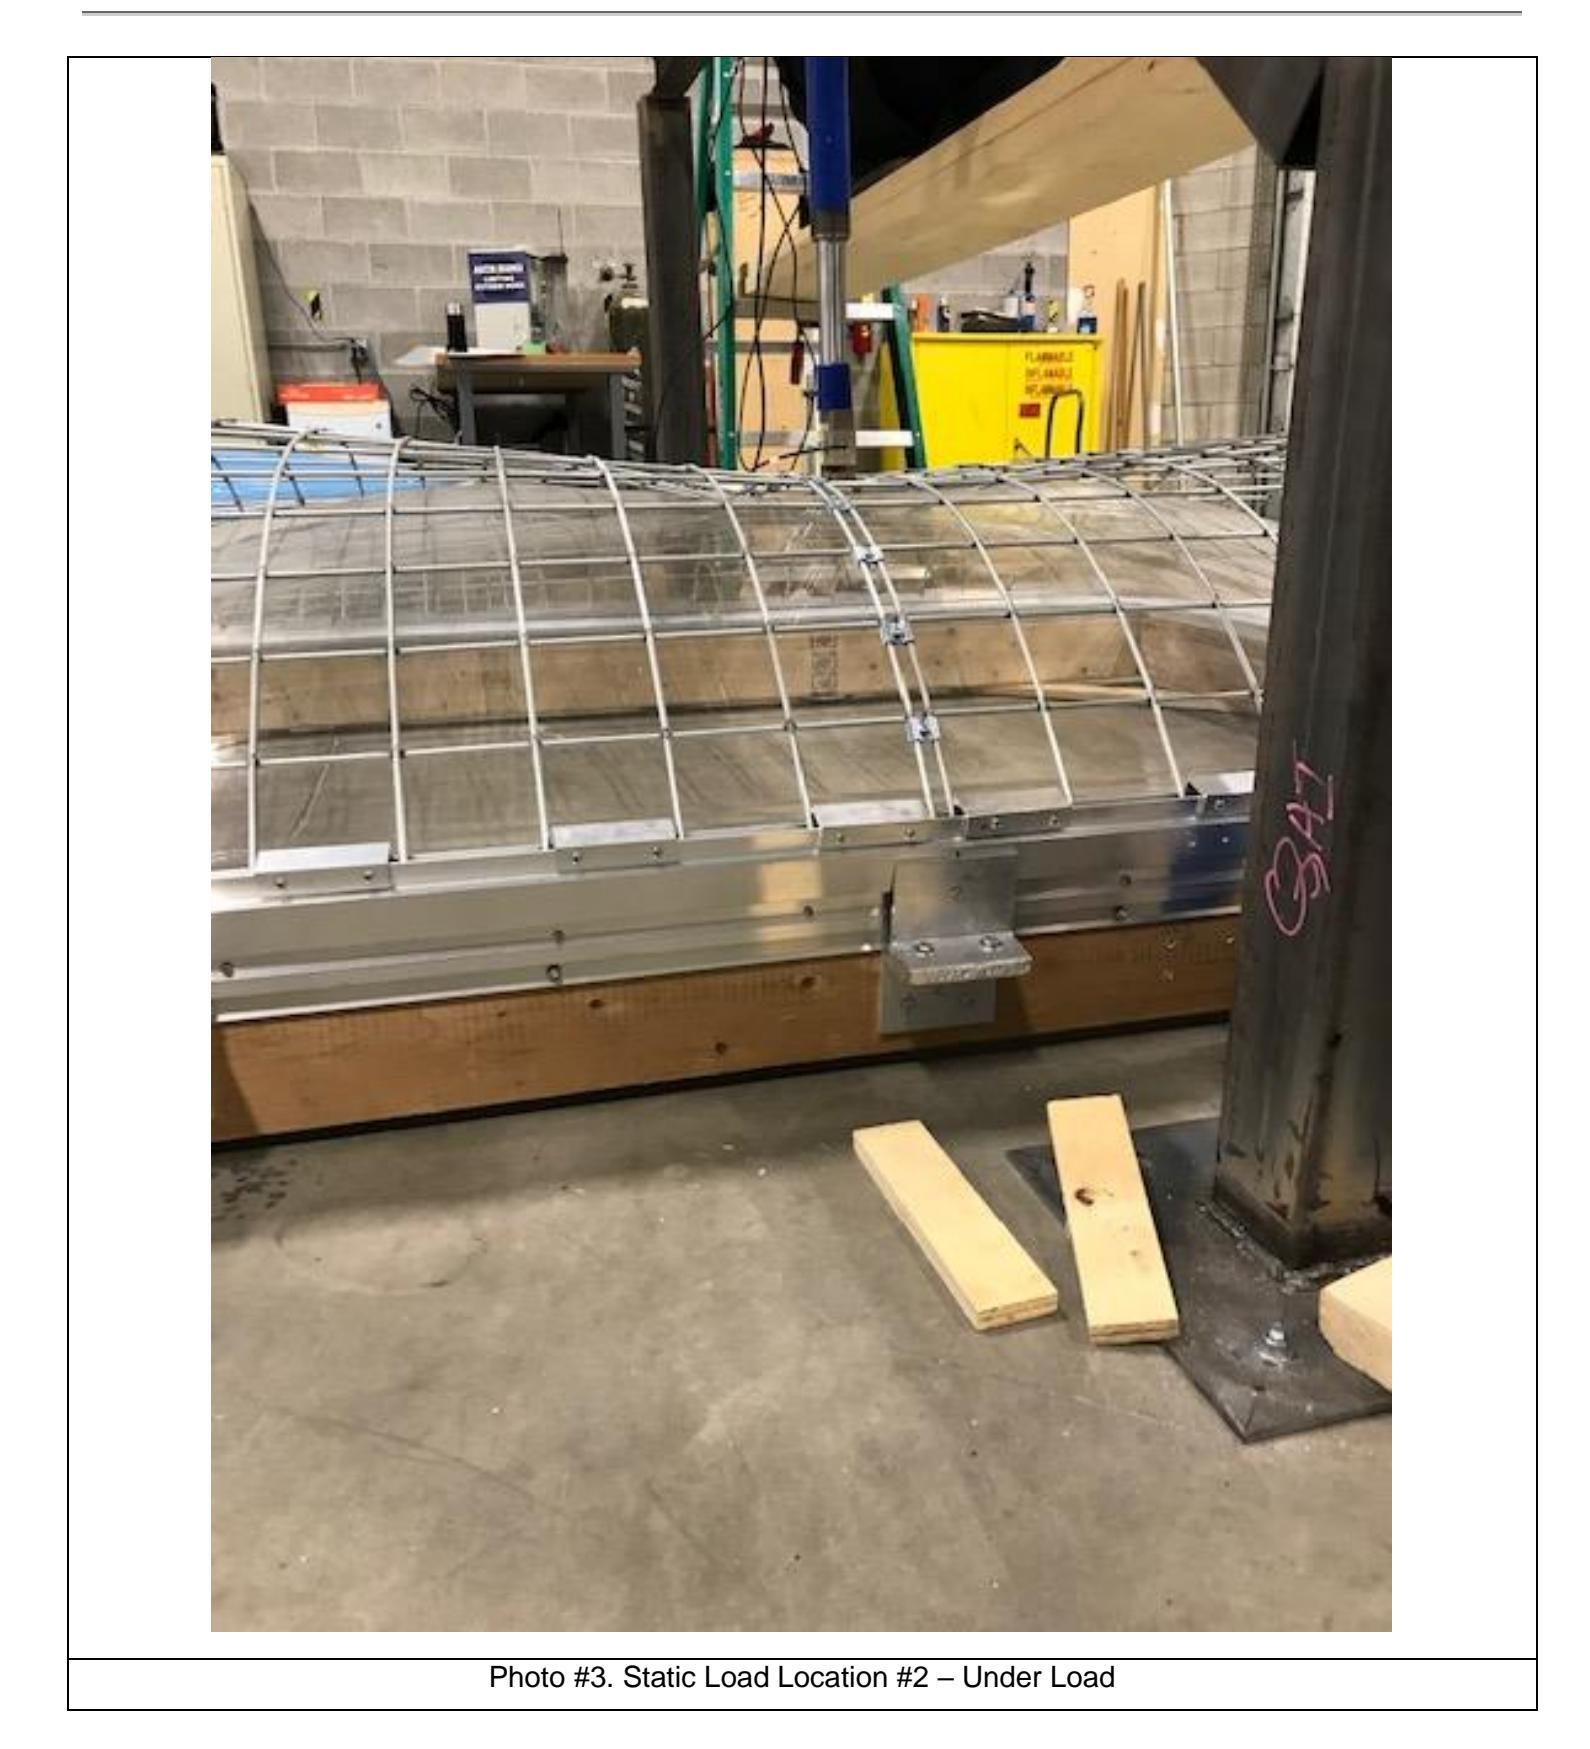
Test Location	Maximum Load (Ibs)	Deflection Under Load, mm (in)	Comments
1	215	323.9 (12.75)	Screen could not maintain higher applied load.
2	725	277.8 (10.94)	No breakage of outer or inner dome.
3	800	127.0 (5.00)	No breakage of outer or inner dome.

The fall protection screen system provided by Artistic Skylight Domes, when tested with static loads, has shown it has the ability to resist breakage and prevent failure of the skylight dome when loaded to the levels and locations noted above.
